TECHNICAL BULLETIN #1

PINHOLES AND BUBBLES (OUT-GASSING)

THE PURPOSE OF THIS TECHNICAL BULLETIN IS TO DISCUSS CAUSES OF PINHOLES AND BUBBLES THAT OCCASIONALLY ARISE DURING APPLICATION OF A TOP COAT, THE WAY TO AVOID THEM, AND THE METHOD BY WHICH TO REPAIR THEM.

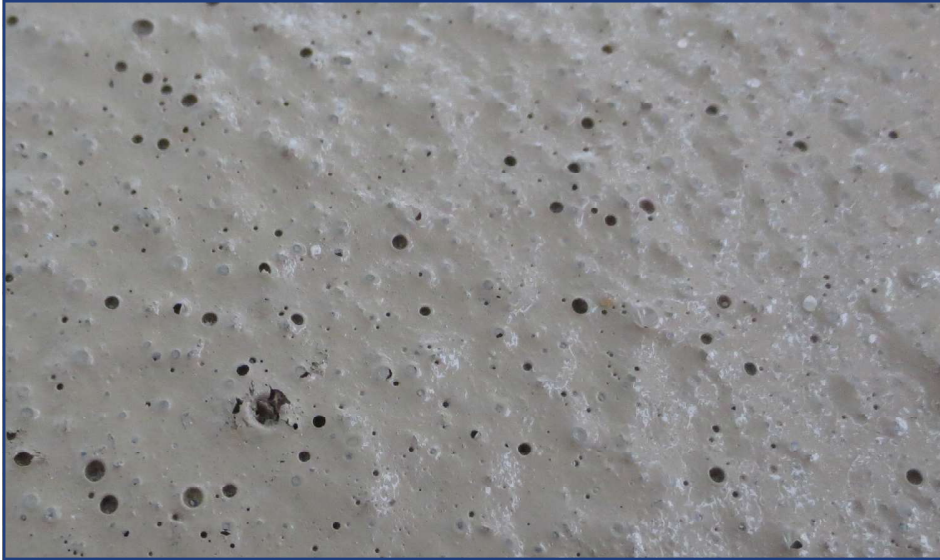
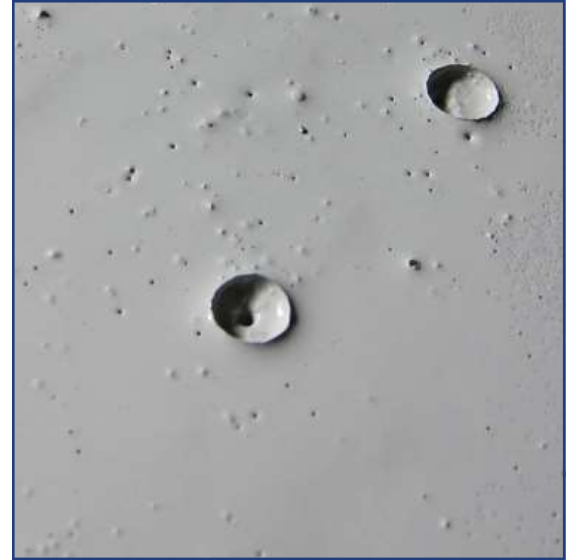
PINHOLES IN TOP COAT DUE TO COATING OUT-GASSING

Pinholes in the top coat appear as small holes. These are generally caused by applying the top coat too thick, or by thinning or diluting the top coat with too much solvent.

Pinholes are created by entrapped solvent trying to escape from the top coat during the curing process. This phenomenon is known as out-gassing. Again, these holes are confined to areas where the top coat has been applied too thick.

Pinholes with corresponding bubbles can also arise by too aggressively applying the final top coat entrapping air into the coating, creating a bubble that leaves a pinhole. These can be avoided by applying the top coat in smooth, even strokes.

Pinholes can be avoided simply by applying the top coat at the published rates contained in the manufacturer's data sheets. They can also be avoided by diluting the top coat with only manufacturer approved commercial grade solvents (xylene or acetone) at no greater a dilution factor of 10% by volume.

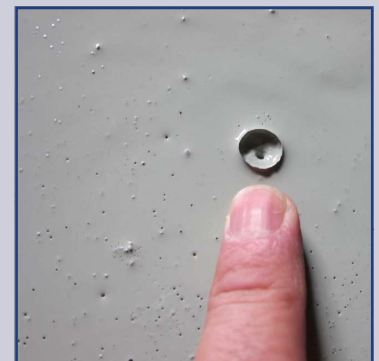
PINHOLES AND A POPPED BUBBLE
REVEALING THE CRATER AND A PINHOLE

1. Clean the coating with a biodegradable cleaner such as Trisodium-phosphate (TSP).
2. Prime the coating with a re-coat primer (such as Polyprime U) followed by broadcasting aggregate into the wet primer at the desired rate.
3. Apply another top coat (Polyglaze AL-50 or Polyglaze 100) at the published rates contained in the manufacturer's data sheets.

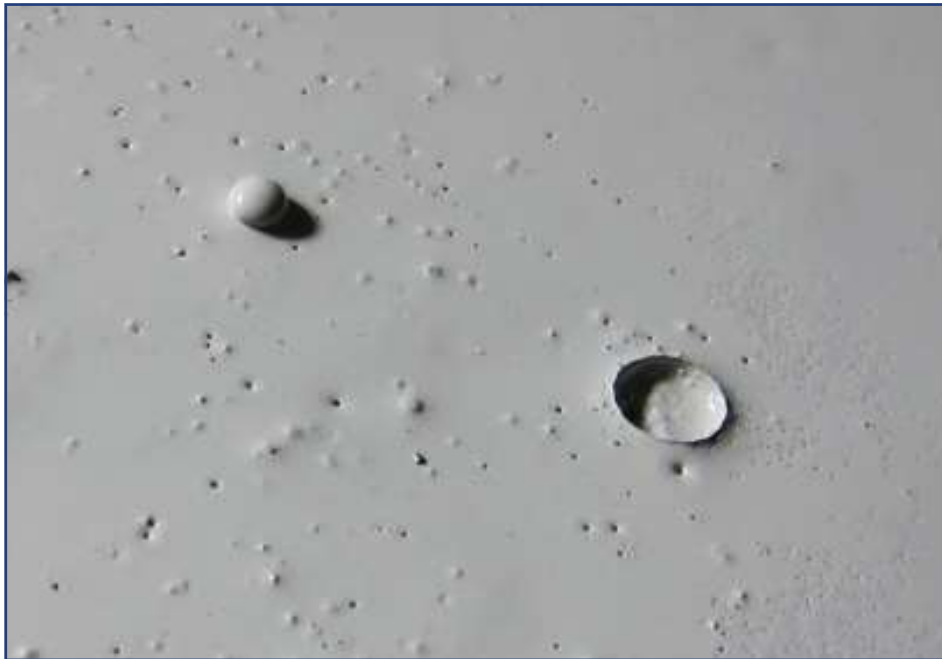
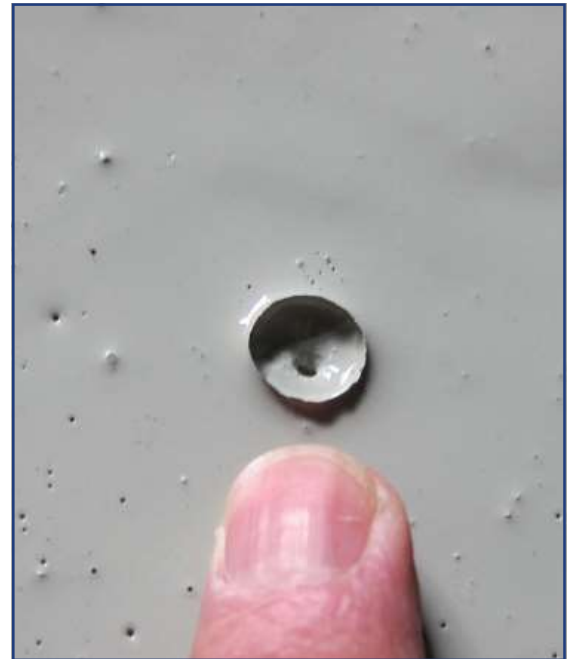
BUBBLES IN TOP COAT DUE TO BUG HOLES IN CONCRETE

This phenomenon happens frequently during application of thin mil aromatic polyurethane vehicular deck coating systems where the system is comprised of a 14-16 mil application of a single component coating used throughout the coating system. The bubbles generally begin to appear during coating application. When they pop or are popped the next day, they leave a round crater with a tiny pinhole in the center.

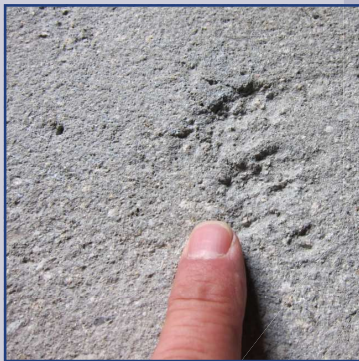
**SUBSTRATE IMPERFECTIONS
LEAD TO PINHOLES AND BUBBLES**

The bubbles are caused when the coating flows into bug holes or small voids that have not been bridged by a primer applied prior to coating application. The coating settles into these voids too thick creating the condition discussed above; the coating skins over, entrapping solvent that is released during the curing process resulting in bubbles. Concrete also breathes out releasing air as temperatures rise; this phenomenon also contributes to bubbling in the coating where it is applied too thick.

Bubbles can be avoided by applying a high viscosity primer (such as Polyprime EBF-LV) to bridge the bug holes and voids that may be present in concrete substrates prior to application of the first coat of the deck coating system. Voids slightly larger than pinholes should be filled with a polyurethane sealant.

Bubbles that appear during coating application may be remedied by misting the bubbles with a commercial grade solvent applied by a Hudson sprayer. The misting process may need to be repeated several times as the bubbles continue to appear. As the solvent hits the bubbles, it pops them allowing the coating to flow back into itself. The bubbles eventually disappear completely.

1. Break or pop the bubbles with a broom or flat squeegee and lightly abrade the ridges or craters as necessary for cosmetic purposes.
2. Prime the affected area(s) with a re-coat primer (such as Polyprime U) followed by broadcasting aggregate into the wet primer at the desired rate. The primer should be applied at a heavier rate (150 square feet per gallon).
3. Apply another top coat (Polyglaze AL-50 or Polyglaze 100) at the published rates contained in the manufacturer's data sheets.
