PARKING STRUCTURE CREW BEATS THE HEAT

Nash Deck Coatings was under pressure to complete the rooftop parking structure at Saddleback Memorial Medical Center during one of Southern California's hottest and longest-lasting heat waves. Did they beat the heat and get the job done?

Recoat top level and access ramps of Saddleback Memorial Medical Center parking structure using Polyprime U and Poly-I-Gard 246SC from Polycoat Products

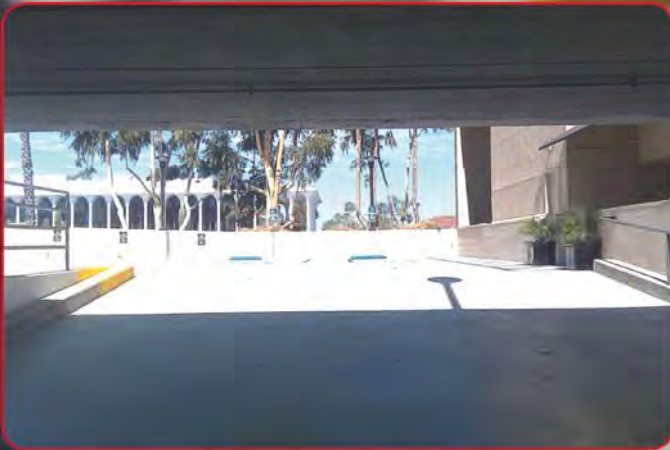
ABOVE ▲ When Saddleback Memorial Medical Center's parking structure coating system failed prematurely, a prolonged heat wave threatened the ability of Nash Deck Coatings to install a new Poly-I-Gard roof deck and access ramp coating system on time. This project would be a trial by fire.

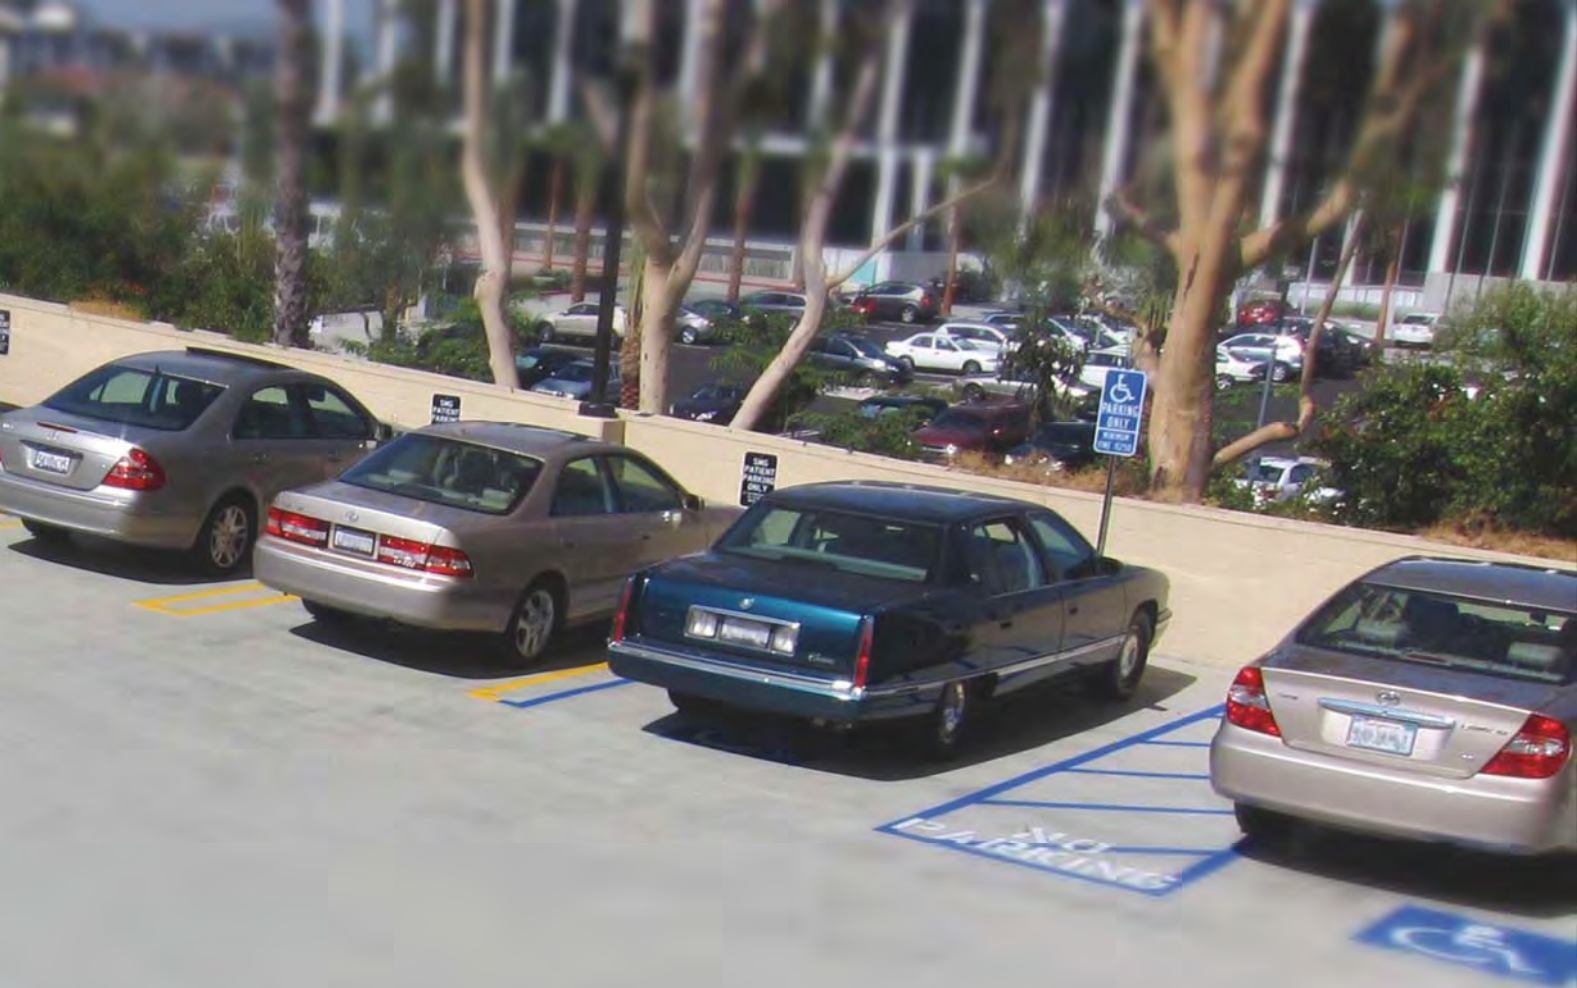
“There was severe peeling and flaking of the existing top coat on the access ramps and roof deck of the parking structure,” explains Nash. “It seems like an inferior product was put down very thin on the deck, and it was peeling pretty badly.”

Something needed to be done to the 15,000-square-foot (1393.5 m²) access ramp and roof deck area to restore safe and functional parking. This is where Nash Deck Coatings and Polycoat Products’ Polyprime U and Poly-I-Gard 246SC came into the picture.

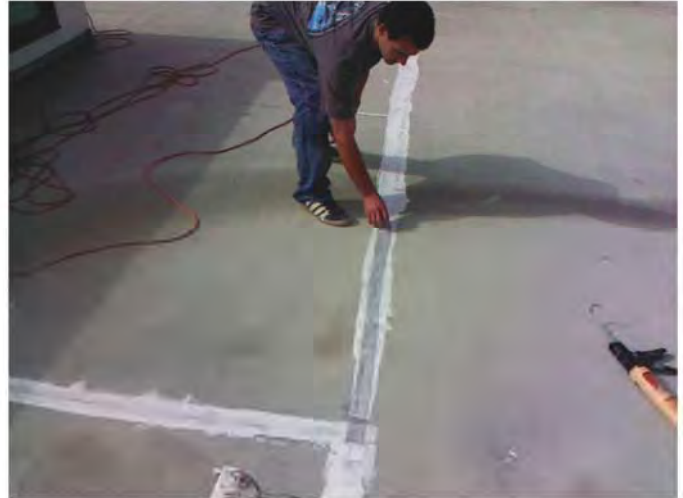
RIGHT ▶ Nash Deck Coatings waited two weeks for the mercury to drop but the heat wave persisted. With time running out, the crew had no option but to jump out of the frying pan and into the fire. The Nash crew power washed, ground off the old topcoat, and caulked the cracks and gaps.

After making the decision to go ahead with the job, Nash and his five-man crew began the surface preparation. The entire roof deck area and all access ramps were power-washed using a 3,500 psi (24.1MPa) Landa-brand power washer.

Once the deck was power-washed, the crew got down to the business of removing the existing top coat using a Clarke floor grinder. The deck was divided into three sections and each section was prepped, repaired (if necessary), primed, and coated before moving on to the next section.

In all the sections, the crew made concrete repairs as necessary before moving on to priming and coating. Depending on the severity of the cracks, the crew used gun-grade urethane, embedded carbon fiber tape, and/or caulking to bridge the gaps.

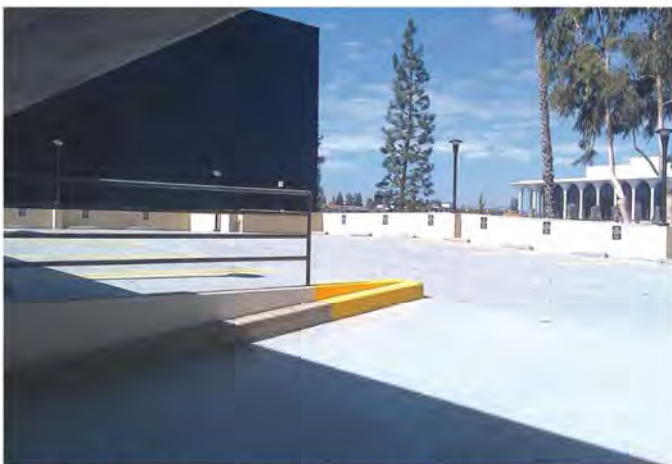
ABOVE ▲ Since the urethane base coat from the existing coating system was usable, the Nash crew was able to save their client the time and expense of having the affected areas stripped down to bare concrete.

Since the Polycoat Products coatings passed the adhesion tests by adhering to the existing urethane base coat, it was determined that only the top coat needed to be completely removed — the base coat could remain on the concrete substrate — thus saving the client a great deal of money and time.
