20 MILLION GALLON CONCRETE WATER TANK LINED WITH ELASTOMERIC POLYUREA

3 ACRES OF POLYEURO 1050H ELASTOMERIC URETHANE/UREA AT 80 MILS

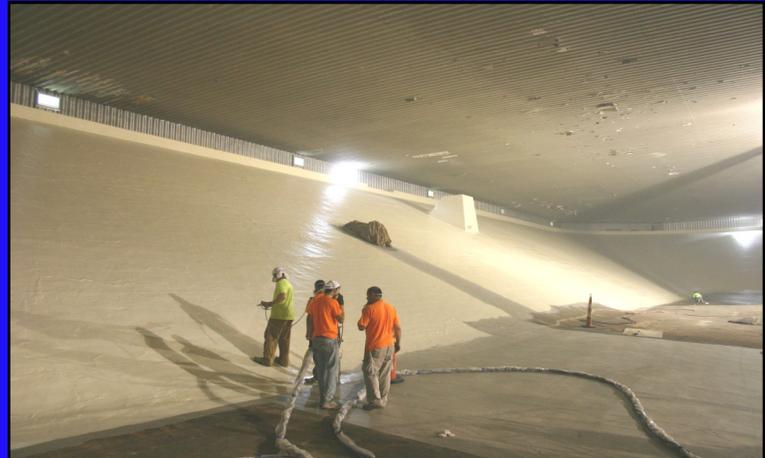
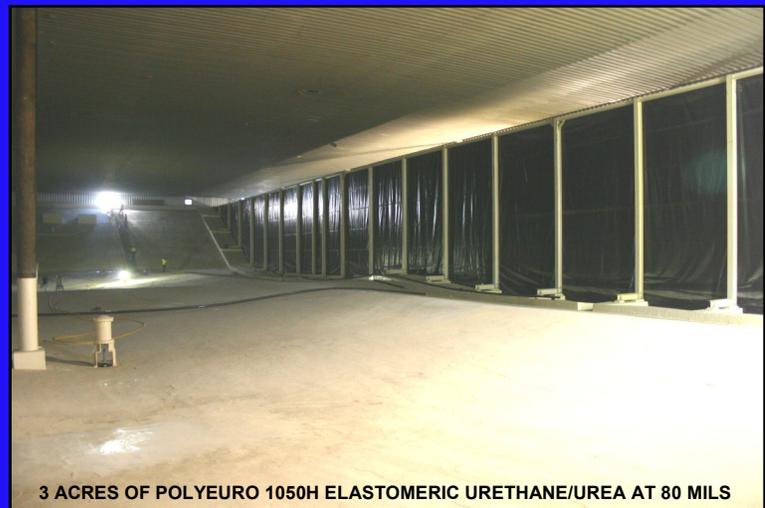
PLURAL SPRAY OF POLYEURO 1050H
